A GRAND MISSION: NEARLY TEN YEARS OLD AND FEELING SLUGGISH!

BY TODD AVERS
SEVEN SLOT OFFROAD

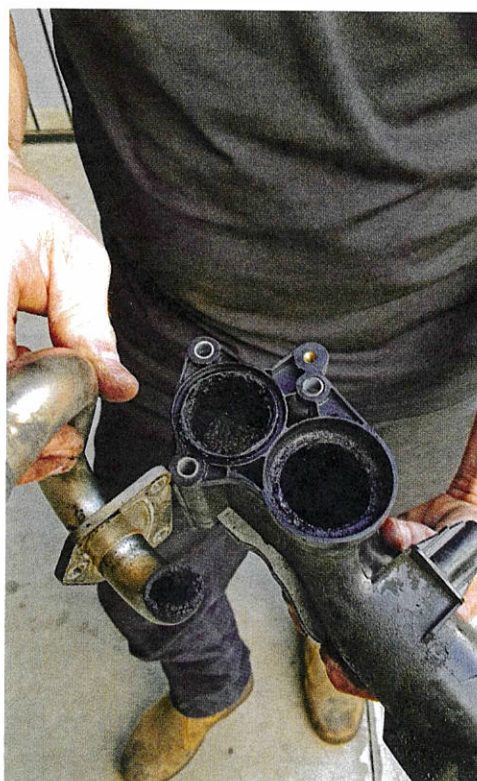
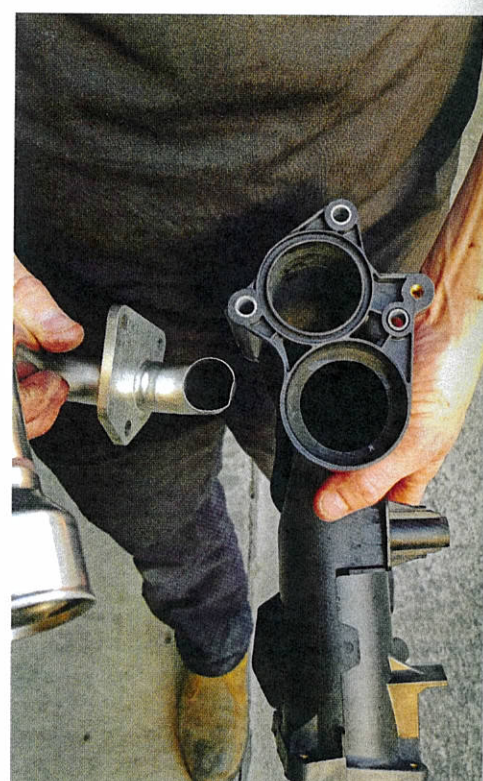
I drove the Grand for about 15km after the clean and then raised it on the hoist again. We discovered the oil was like a running river out of the centre of the engine under the turbo and exhaust. We tried to find the source, but still could not clearly see it.

Lowering the hoist we removed the last of the turbo bolts and then the turbo to find the leak at the oil feed/return housing where a steel gasket sat. There are four bolts that hold the housing to the engine, which were loose. We cleaned out the valley of the engine and the front drain hole, which is where the oil is meant to travel if a leak happens. This hole travels through a casing in the block and exits behind the a/c compressor. We replaced all the gaskets and moved to getting the turbo back on and the drivetrain back in to place. As the customer tows his Jeep Wrangler with this Jeep we thought it was time we did a full service on the auto, transfer and diffs to make sure all was in perfect order.

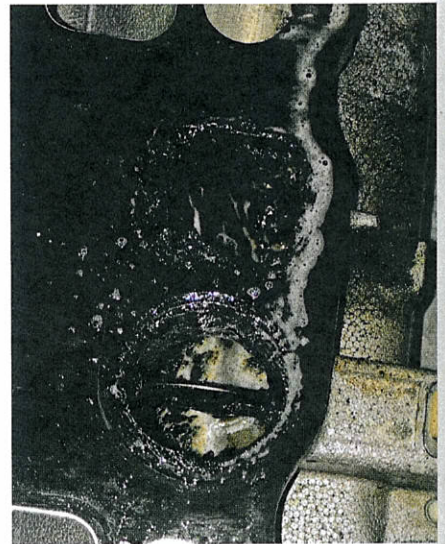
As for the sludge and soot build up in the intake, this is caused by the EGR air heating up the oil that passes through the PCV system and clogging the intake manifold. To prevent this we have fitted a catch can in the system before it is released into the intake pipe after the turbo.

We are going to have a look in the intake system after a few thousand kilometres to see if the catch can is making a difference and keeping the vital entry to the engine clean and in good working condition.
